LAVANT NEIGHBOURHOOD DEVELOPMENT PLAN 2016 - 2031

Historical flooding in Lavant

Lavant Parish Council

December 2016

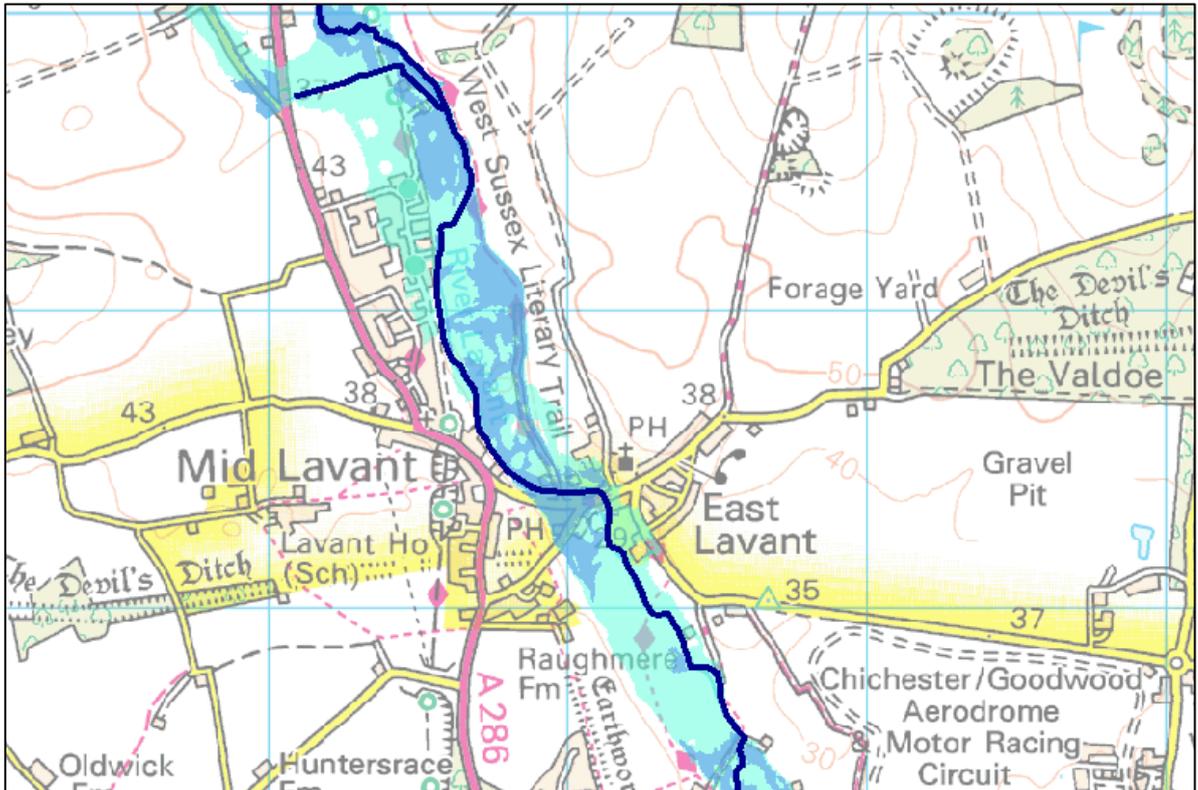
- **Flood Zone 3** *This zone comprises land assessed as having between a 1 in 100 and 1 in 1,000 annual probability of river flooding (1% – 0.1%), or between a 1 in 200 and 1 in 1,000 annual probability of sea flooding (0.5% – 0.1%) in any year*
- **Flood Zone 2** *This zone comprises land assessed as having a 1 in 100 or greater annual probability of river flooding (>1%), or a 1 in 200 or greater annual probability of flooding from the sea (>0.5%) in any year.*

2.03 The flood risk in this area is impacted by groundwater springs adding to the flood water. This is not accounted for within the Environment Agency Flood Zones which look at rivers and the sea. This focus makes the definition of a functional floodplain in the LNDP area more complex as there is a lack of EA evidence to support a change of outline.

2.04 Current guidance on identifying the functional floodplain states that it should take account of local circumstances and not be defined solely on rigid probability values. Thus the core flood plain is considered as synonymous with the functional flood plain.

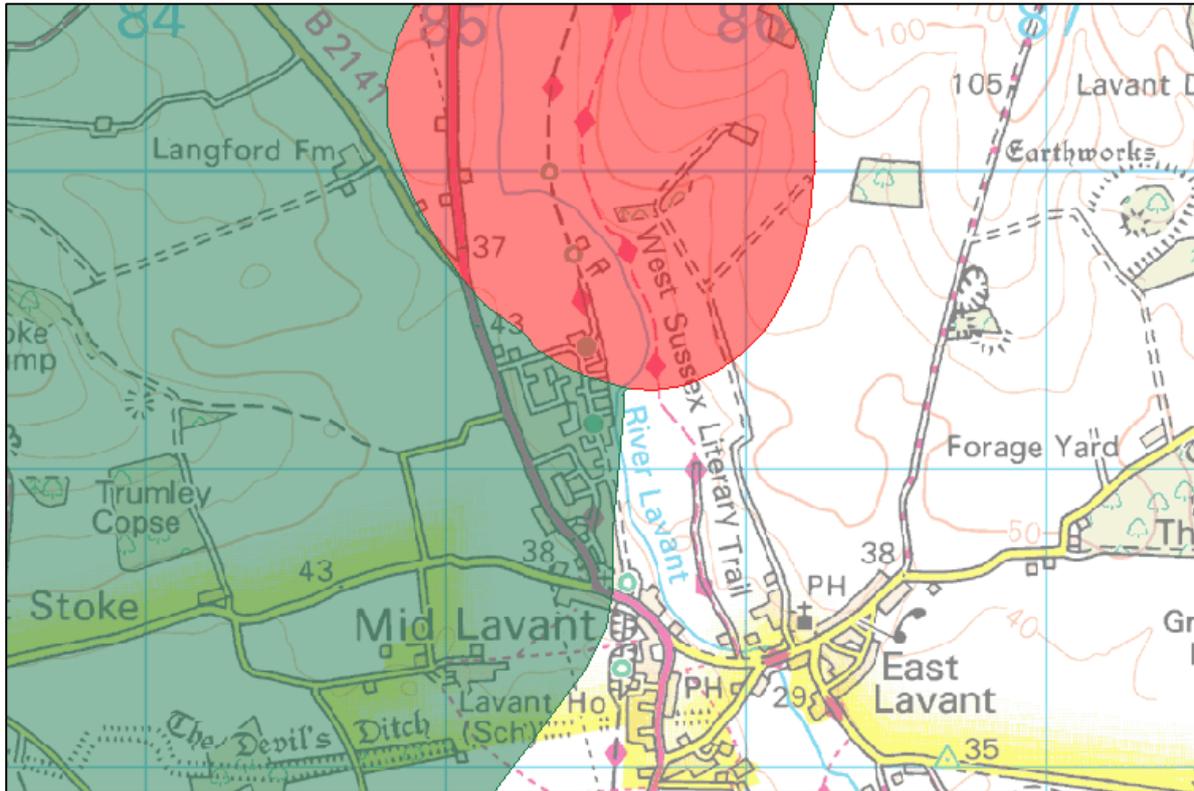
- **Inner zone (Zone 1)** - Defined as the 50 day travel time from any point below the water table to the source. This zone has a minimum radius of 50 metres;
- **Outer zone (Zone 2)** Defined by a 400 day travel time from a point below the water table. The previous methodology gave an option to define SPZ2 as the minimum recharge area required to support 25 per cent of the protected yield. This option is no longer available in defining new SPZs and instead this zone has a minimum radius of 250 or 500 metres around the source, depending on the size of the abstraction;

- 2.07 Flooding also occurs as a result of heavy rainfall on saturated catchments which cause river levels to rise rapidly and flow over the river bank. This overtopping occurs when already high river levels (caused by high groundwater levels) are exacerbated by a series of intense rainfall events. This causes problems in Singleton and Mid/East Lavant particularly.
- 2.08 The diagram below published by the Environment Agency shows where ground water flooding is most likely to occur in the parish. It clearly shows that the area to the north of the parish is most likely to flood from this source

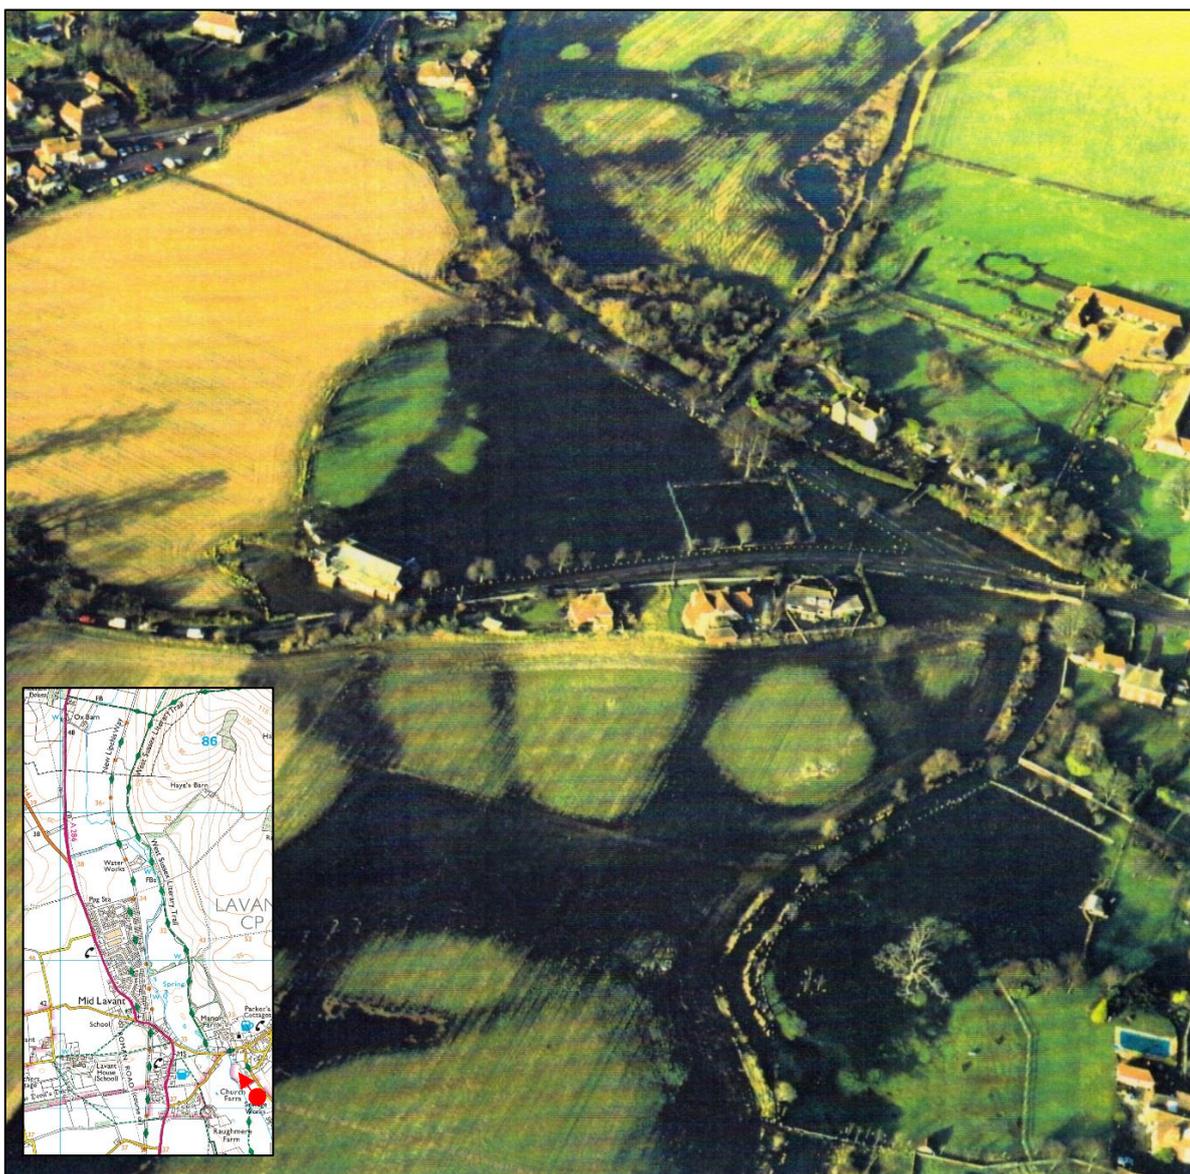
Figure 4 - Aerial photograph looking northwest up the River Lavant from a position above Church Farm. The village green is in the centre of the photo with the Lavant Memorial Hall surrounded by flood water.

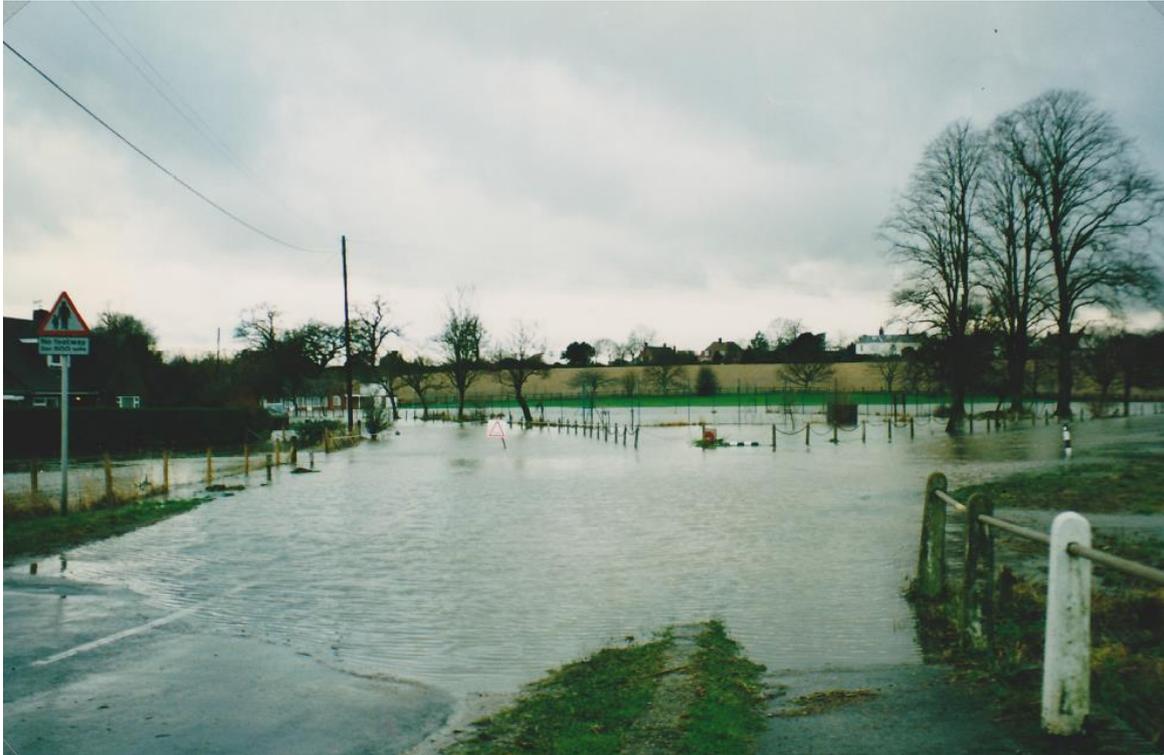
Figure 5 - The junction of Sheepwash Lane and Pook Lane looking towards the village green. The photo is taken from the road bridge and shows the result of the river overtopping and finding a new route.

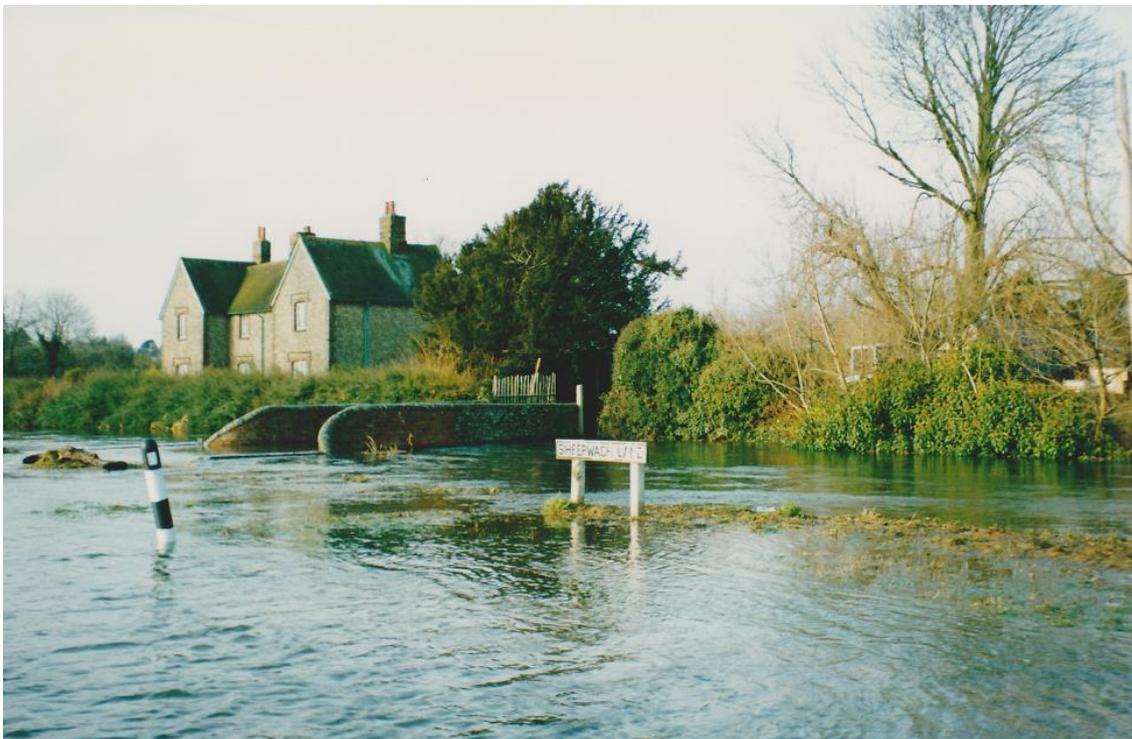
Figure 6 - Properties in Sheepwash Lane. The normal flow of the river restricted by the bridges and thus overtopping of the bank occurred.

- 3.04 In East Lavant, the village green has flooded due to blockages at the bridges which cross over from Sheepwash Lane.
- 3.05 In all recent floods the **LAG TIME** between excessive rainfall and flooding is very short as the ground is already saturated and the river is already running close to capacity. Thus over capacity and flooding can happen over overnight.

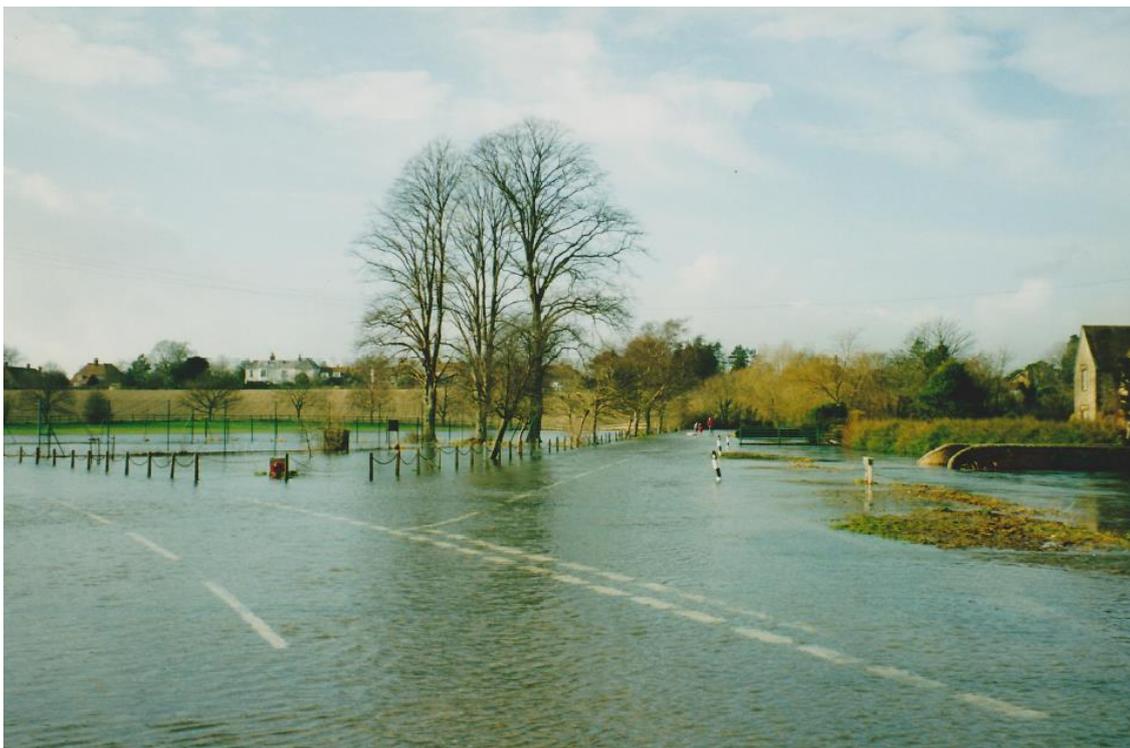
Figure 7 - Looking west along Sheepwash Lane. The river course is on the right of the picture.

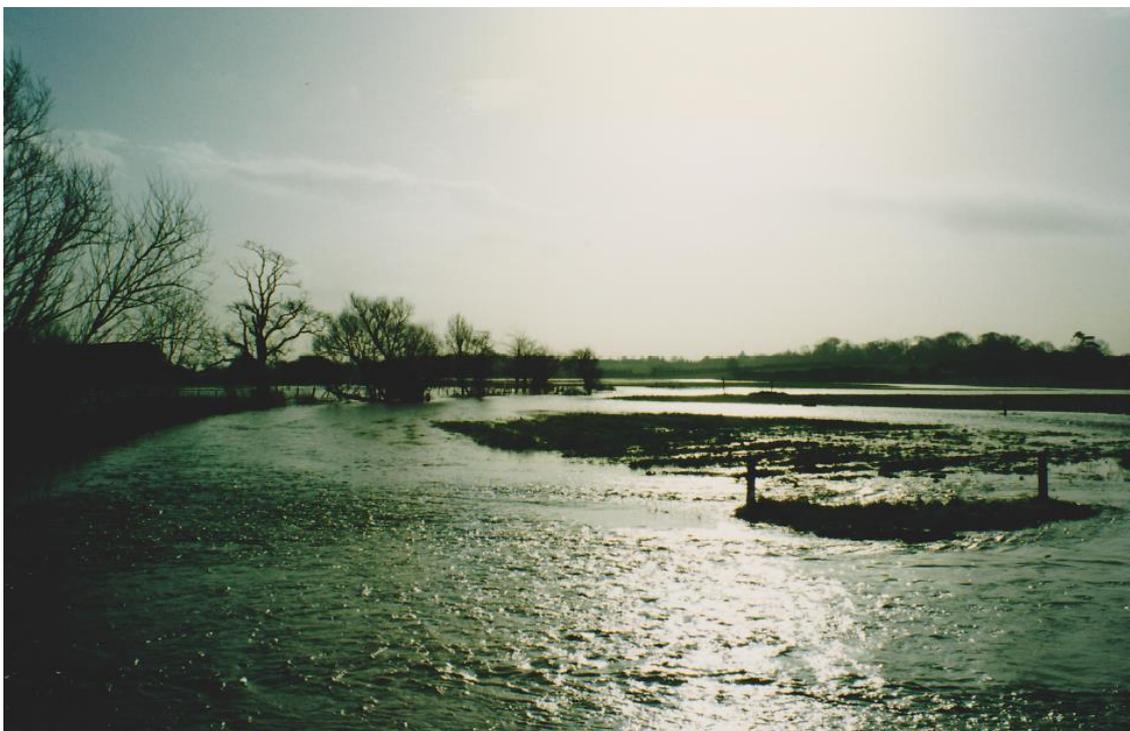
Figure 8 - Fields looking south from Pook Lane. The river flows on the left of the photo.

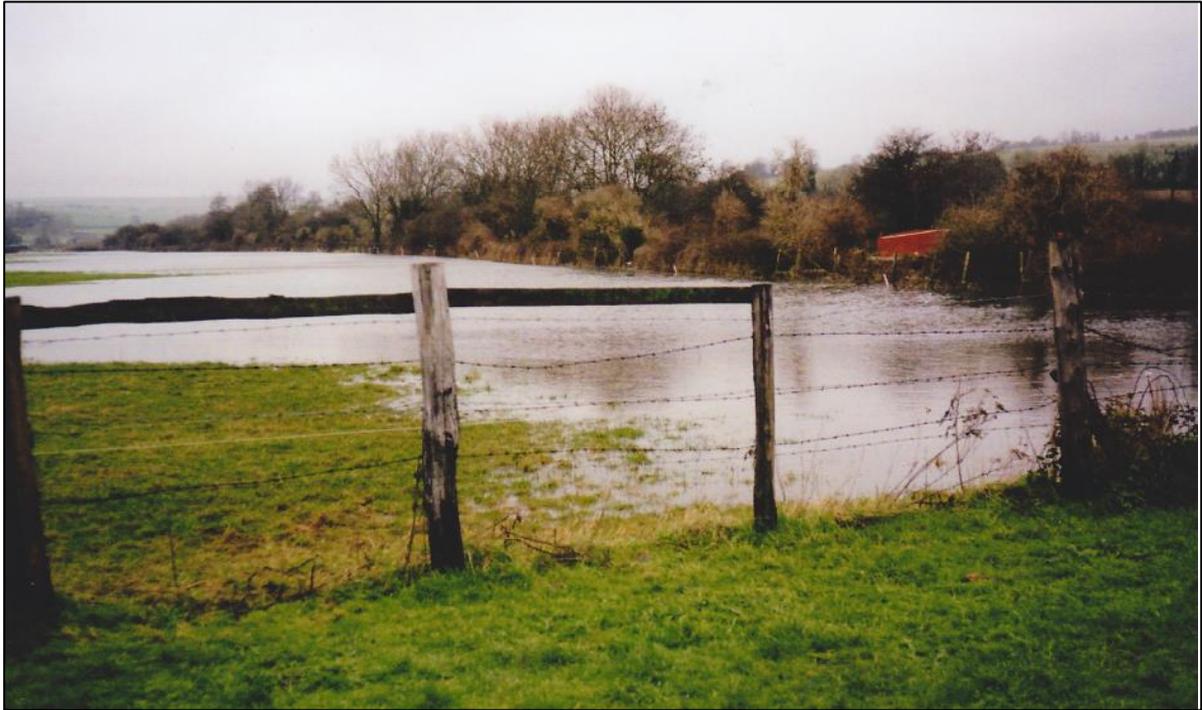
Figure 9 - 1994 Looking north from Lavant Down road with the line of trees on the west edge of Centurion Way.

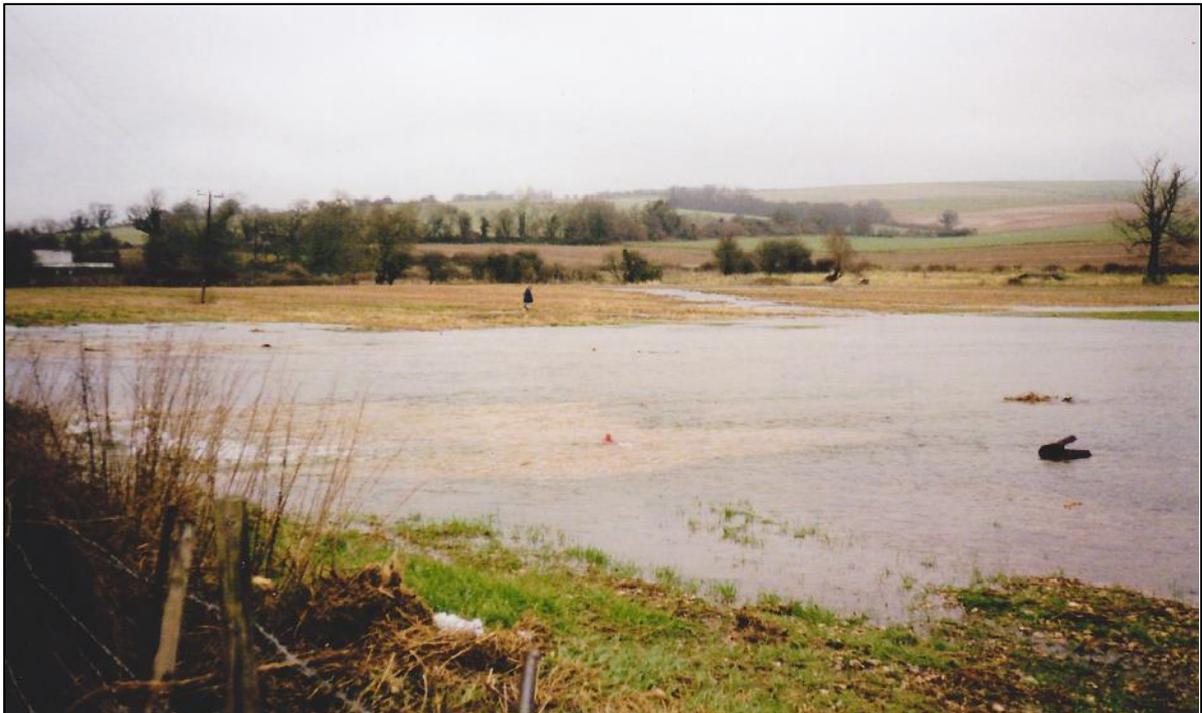
Figure 10 - 1994 Looking NE across the water meadows from the edge of the Mid Lavant settlement area.

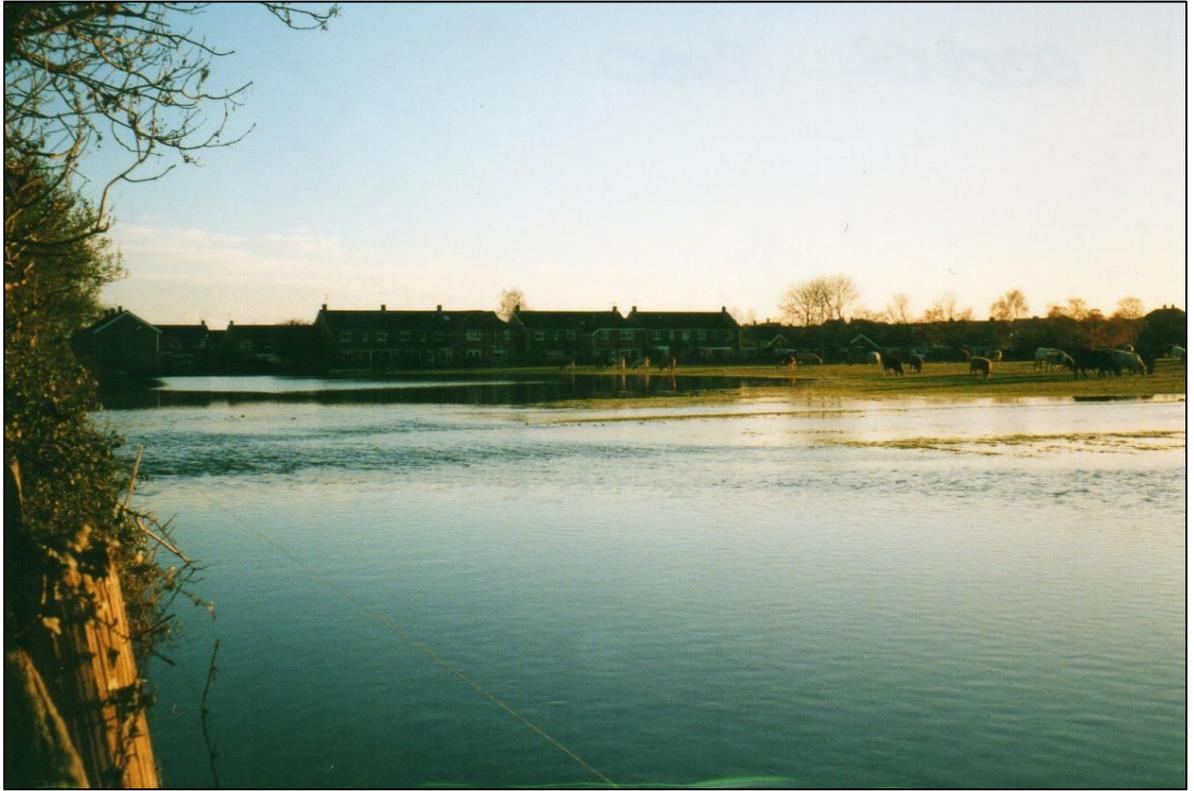
Figure 11 - Looking towards Lavant Down Road from the north.

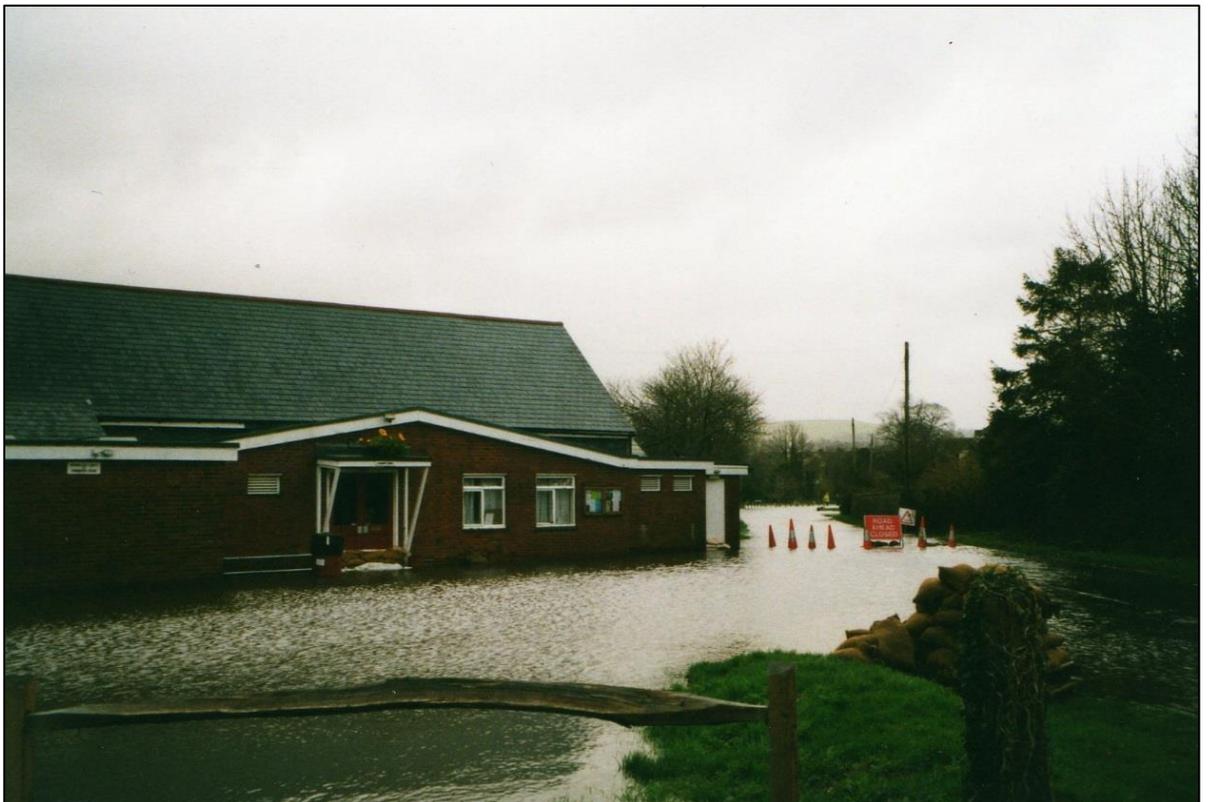
Figure 12 - 2000 The village hall and Pook Lane looking north.

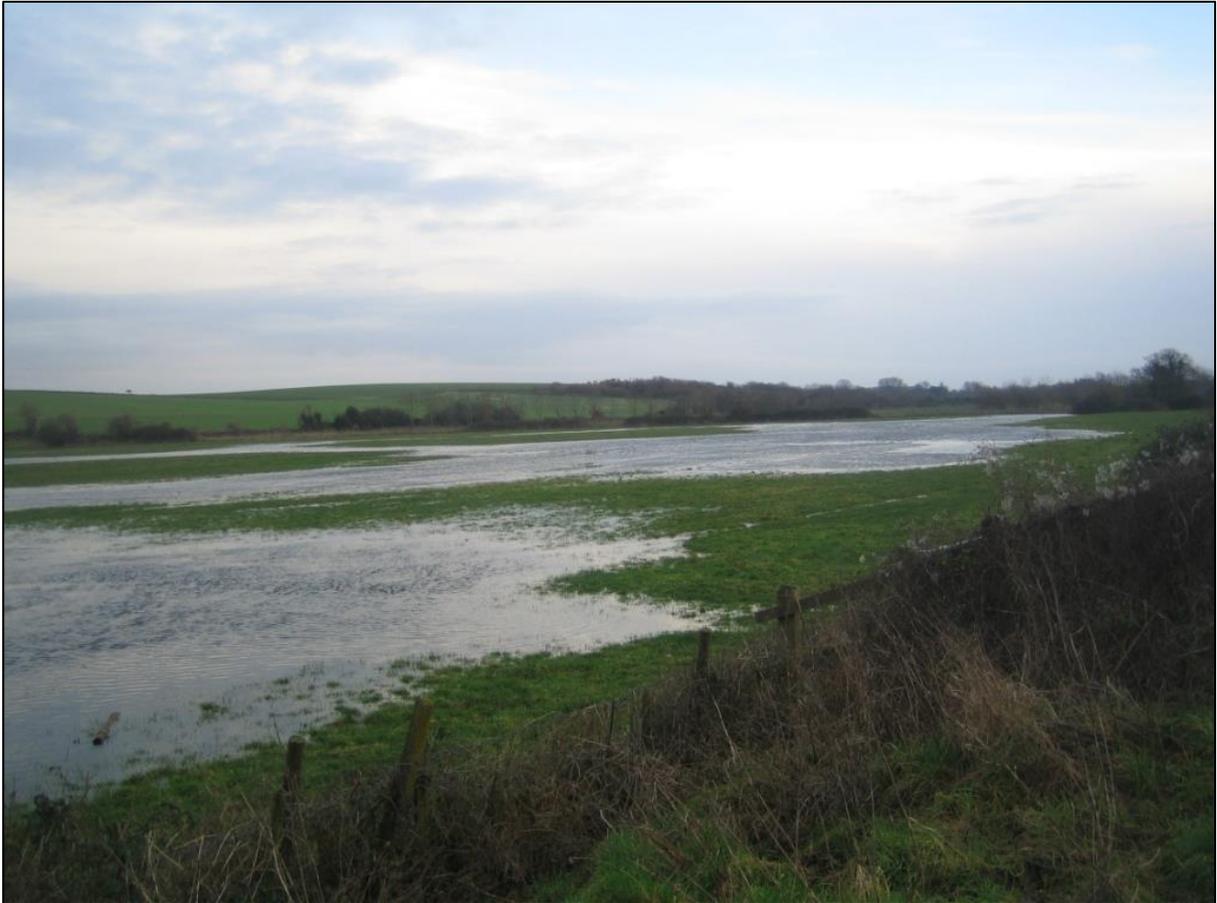
Figure 13 - 2014 Looking south down the core flood plain from the pumping station road.

3.11 The Lavant River flooded. There were no substantial issues in relation to properties however, the inundation of the sewerage system created major concerns and required the deployment of tankers for many weeks to prevent unacceptable sewerage discharge into the river.

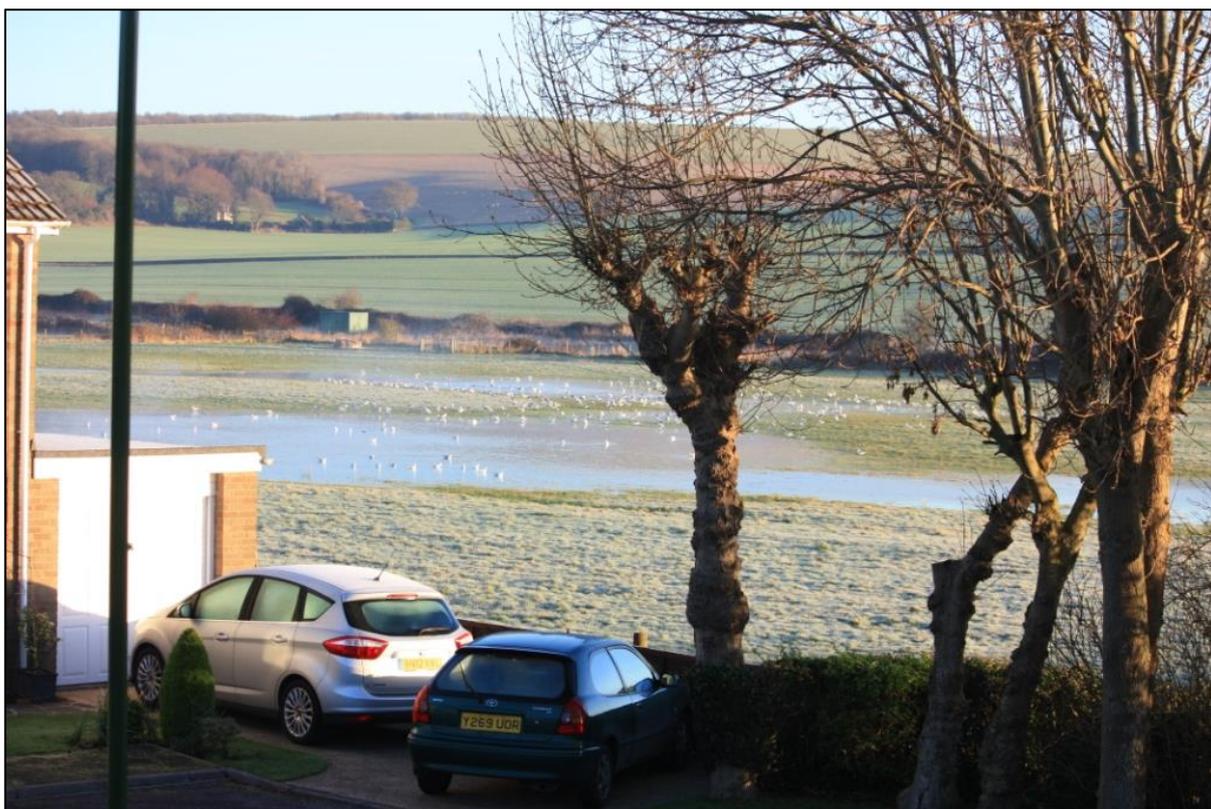
Figure 14 - 2014 View from St Mary's Close looking east.
